# Identifying archaeological evidence of past earthquakes in a contemporary disaster scenario: case studies of damage, resilience and risk reduction from the 2015 Gorkha Earthquake and past seismic events within the Kathmandu Valley UNESCO World Heritage Property (Nepal)

**Keywords** Kathmandu · Nepal · South Asia · Archaeoseismology · Earthquake Archaeological Effects (EAEs) · Resilience · Seismic adaptations · Rehabilitation

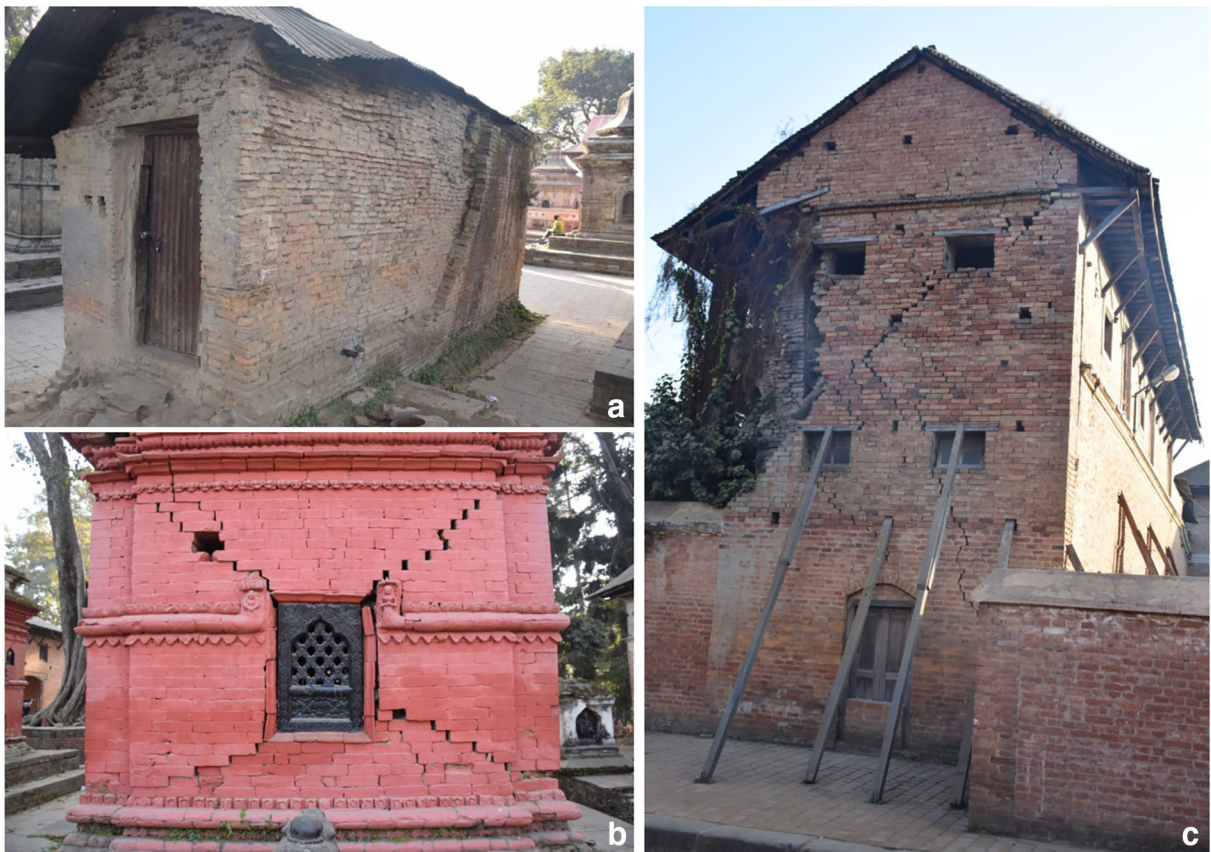
**Fig. 3** Tilted wall at a structure at Mrigasthali in Pashupati (a); ‘X’ fracture through a brick built shrine at Mrigasthali in Pashupati (b); shear cracks through one of the walls within Bhaktapur Palace Complex (c)

Tilted walls, close to collapse, were found at several structures, including a clear example at a building within the Mrigasthali area of Pashupati (Fig. 3a). Of monuments where full collapse had not occurred, fractured walls, including shear cracks and 'X' fracture patterns through wall facades were common at stone and brick structures, particularly wood-framed buildings with brick infills. Occasionally, these cracks were caused by wall extrusions across the facades of structures. Examples of fracturing were found, but were not limited to, structures in Mrigasthali (Fig. 3b), the Jagannath temple in Hanuman Dhoka's Durbar, or palace, Square and at structures within Bhaktapur's palace complex (Fig. 3c). At Pashupati, in some instances, it was possible to identify vertical cracks linked to the displacement of walls. More complex patterns of cracks were identified at the Shiva temple located within Hanuman Dhoka Durbar Square. Here, there was evidence of composite shear cracks associated with the extrusion of a wall, with the wall profile also appearing to be folded. Such seismic damage patterns are caused by horizontal motion, but there was also a strong vertical component present, testified by sub-vertical fractures penetrating vertically. These EAEs were found at the base of the shrine, which is not entirely surprising due to

this being the location where architectural stresses would be higher. Extrusions and the shifting of masonry blocks was also identified, both at collapsed monuments such as the Vatsala Temple in Bhaktapur (Coningham et al. 2016b), but also within the lion statues that are located just within the western gateway of Bhaktapur’s Durbar Square, which now flank the entrance to the Shree Padma Secondary High School (Fig. 4).

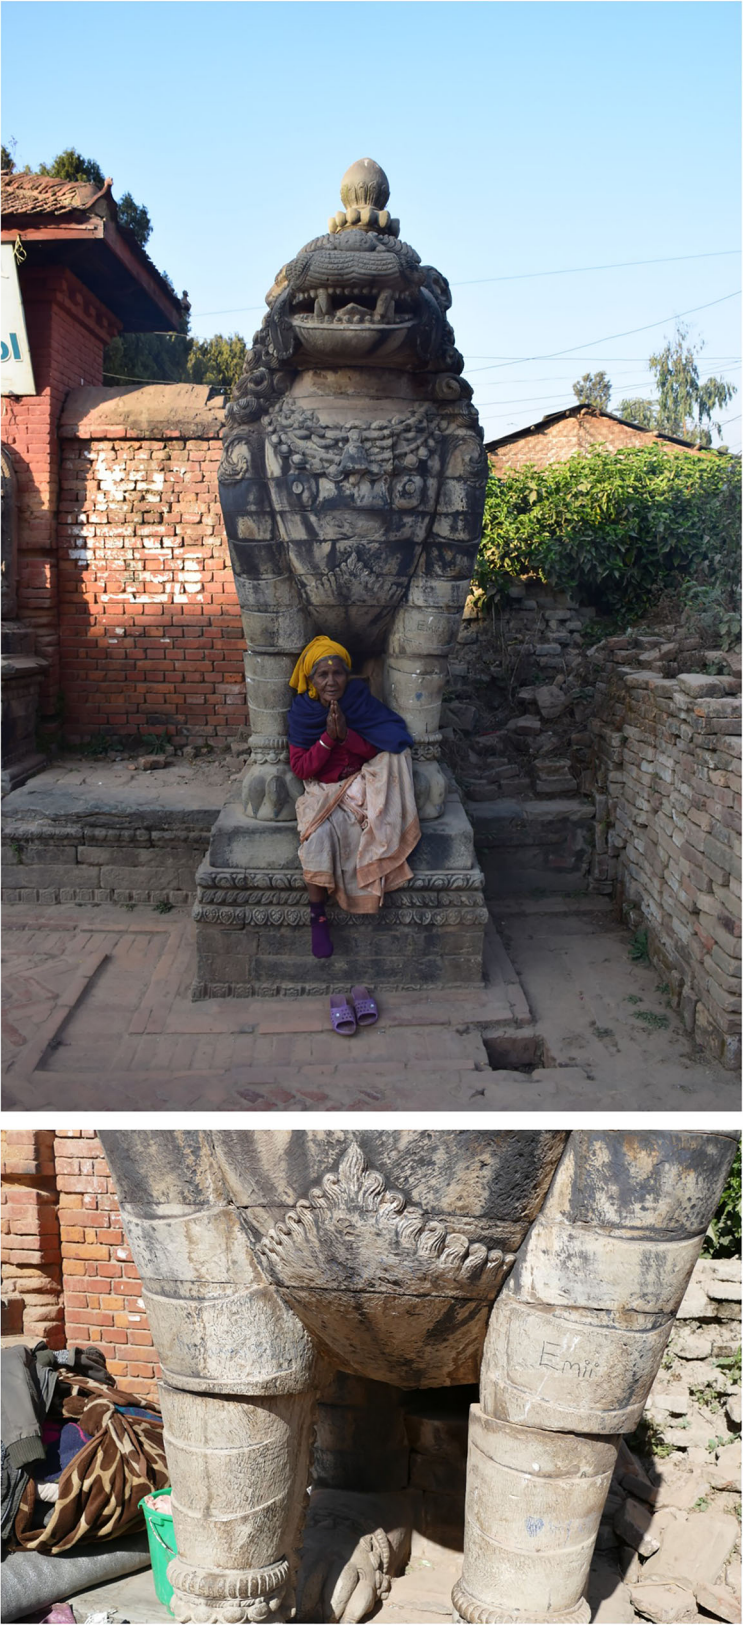
**Fig. 4** Shifted and extruded stone blocks in a lion sculpture at Bhaktapur

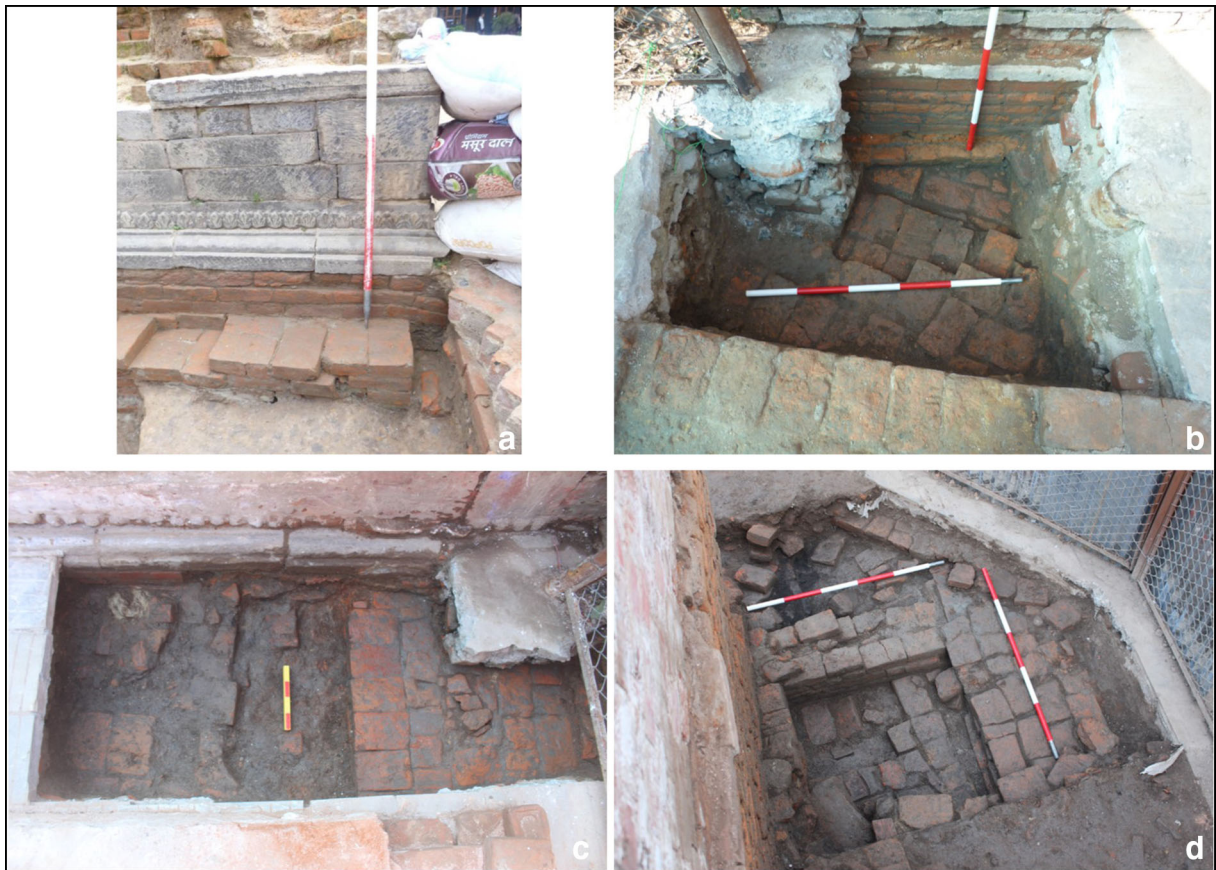
**Fig. 6** The current footprint of the Vatsala Temple in Bhaktapur overlaying and overhanging an earlier brick foundation (a); a large brick wall on a differing alignment running under the plinths of the

Maju Dega Temple, Hanuman Dhoka (b); a structure located below the Trailokiya Mohan Temple to the east (c); and a further structure identified to the south (d)

Furthermore, our archaeological investigations have demonstrated that several current standing structures were erected directly on top of earlier phases. For instance, the footprint of the current stone-clad Vatsala temple within Bhaktapur's Durbar Square, thought to date to between the late seventeenth and early eighteenth century CE (Korn 2014: 29–33, 44, Basukala et al. 2014: 33), is off-set from the brick foundations below. These foundations step out to the west, whilst the superstructure overhangs this lower alignment to the south (Fig. 6a). This suggests the strong possibility of two quite separate phases of construction (Coningham et al. 2016b). Similarly, within Hanuman Dhoka's Durbar Square, we found that the current monumental plinths of the Maju Dega (Fig. 6b) and Trailokiya

Mohan Temples (Fig. 6c, d) had been built directly over earlier phases of construction (Coningham et al. 2018: 165). The scientific date for a structure identified running under the west of the Trailokiya Mohan temple, extracted from an Optically Stimulated Luminescence sample of the soil forming the wall's construction surface, was  $1040 \pm 120$  CE. This is around 600 years prior to the traditional date of 1679 CE for the monument constructed above. This earlier wall may relate to a monument that was cleared to make way for its development (Hutt 1994: 85), although whether this earlier monument was damaged by earthquakes is not clear as the traditional construction date is slightly prior to the historic record of the 1681 CE earthquake. Such a scenario may be more plausible for the Maju Dega temple, with construction traditionally ascribed to 1690 CE (Hutt 1994: 88), and would link to the proliferation of large stepped plinth temples in the Kathmandu Valley in the late seventeenth century (Tiwari 2009). However, without historic records and until clearer scientific dating sequences are available, such an assertion is conjectural and it is not possible to link these episodes of levelling or reconstruction definitively as responses to seismic events. However, it remains a possibility alongside other opportunistic reasons for remodelling urban space.

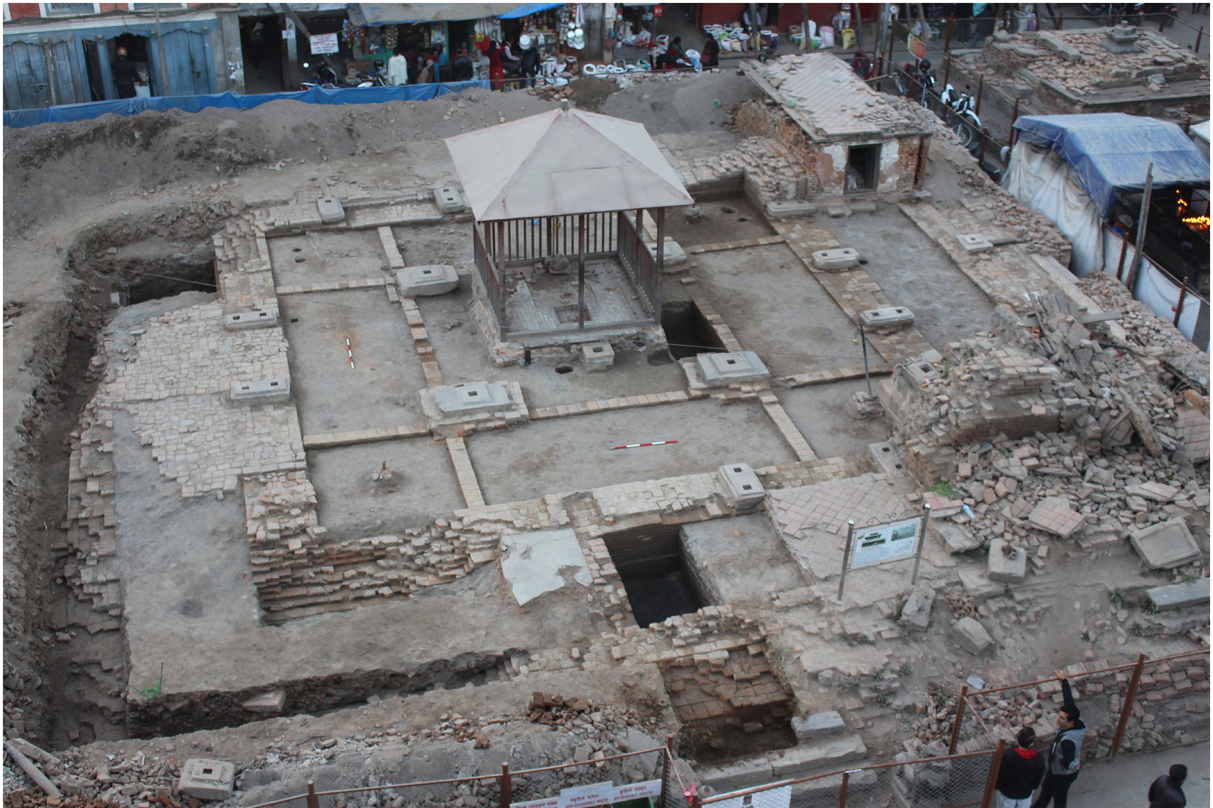
**Fig. 9** Nine-celled mandala formed through brick-piers, foundation wall and cross-walls uncovered during archaeological assessments at the Kasthamandap

Collapsing during the hosting of a temporary blood donation clinic, efforts to recover the trapped, injured and dead included the use of heavy machinery. During our excavations, we found evidence of the damage caused by this post-earthquake emergency intervention in the form of dug-out foundations and scrape marks scoring the surface of the tiled floor (Coningham et al. 2016d). This floor had been laid around several saddle stones, which contained sockets to interconnect with the tenons of the wooden superstructure. In particular, the four major wooden pillars of the Kasthamandap were linked to four large saddle stones around the central Gorakhnath shrine. Excavations revealed that these saddle stones sat on brick piers set in mud mortar, each 2 m deep. These were surrounded by a large squared  $12 \times 12$ -m foundation wall, also 2 m deep and constructed from brick and mud mortar, with smaller double saddle stones placed on its surface to link to the timber superstructure (Fig. 9). We identified that the large saddle

We also identified that the monument may have had been designed with inbuilt cosmological protection, as cross-walls, scientifically dated to 200 years after the monument's original construction, running between the brick piers and foundations, forming a nine-celled mandala design (a representation of the universe in microcosm). These cross-walls may have also formed some aspect of seismic bracing for the foundations. It has further been identified that the infills deposited within

the ‘cells’ formed by the cross-walls were purposefully prepared with soils and materials brought from outside. Preliminary geoarchaeological analysis suggesting that these deposits may have aided earthquake dampening for the monument’s foundations, and the thoughtful compositions of soils placed within the monument’s foundations may have taken on a symbolic significance, which has been recorded in textual sources (Coningham et al. 2019: 63). Further cosmological protection was identified with the recovery of gold foil discs with mandala designs within each of the sockets of the central saddle stones (Coningham et al. 2016d). Such deposits may have provided a ‘life-breath’ to a building and afforded its protection, as well as the prosperity and welfare to those performing the ceremony during the construction of a monument (Slaczka 2007: 84, 201).

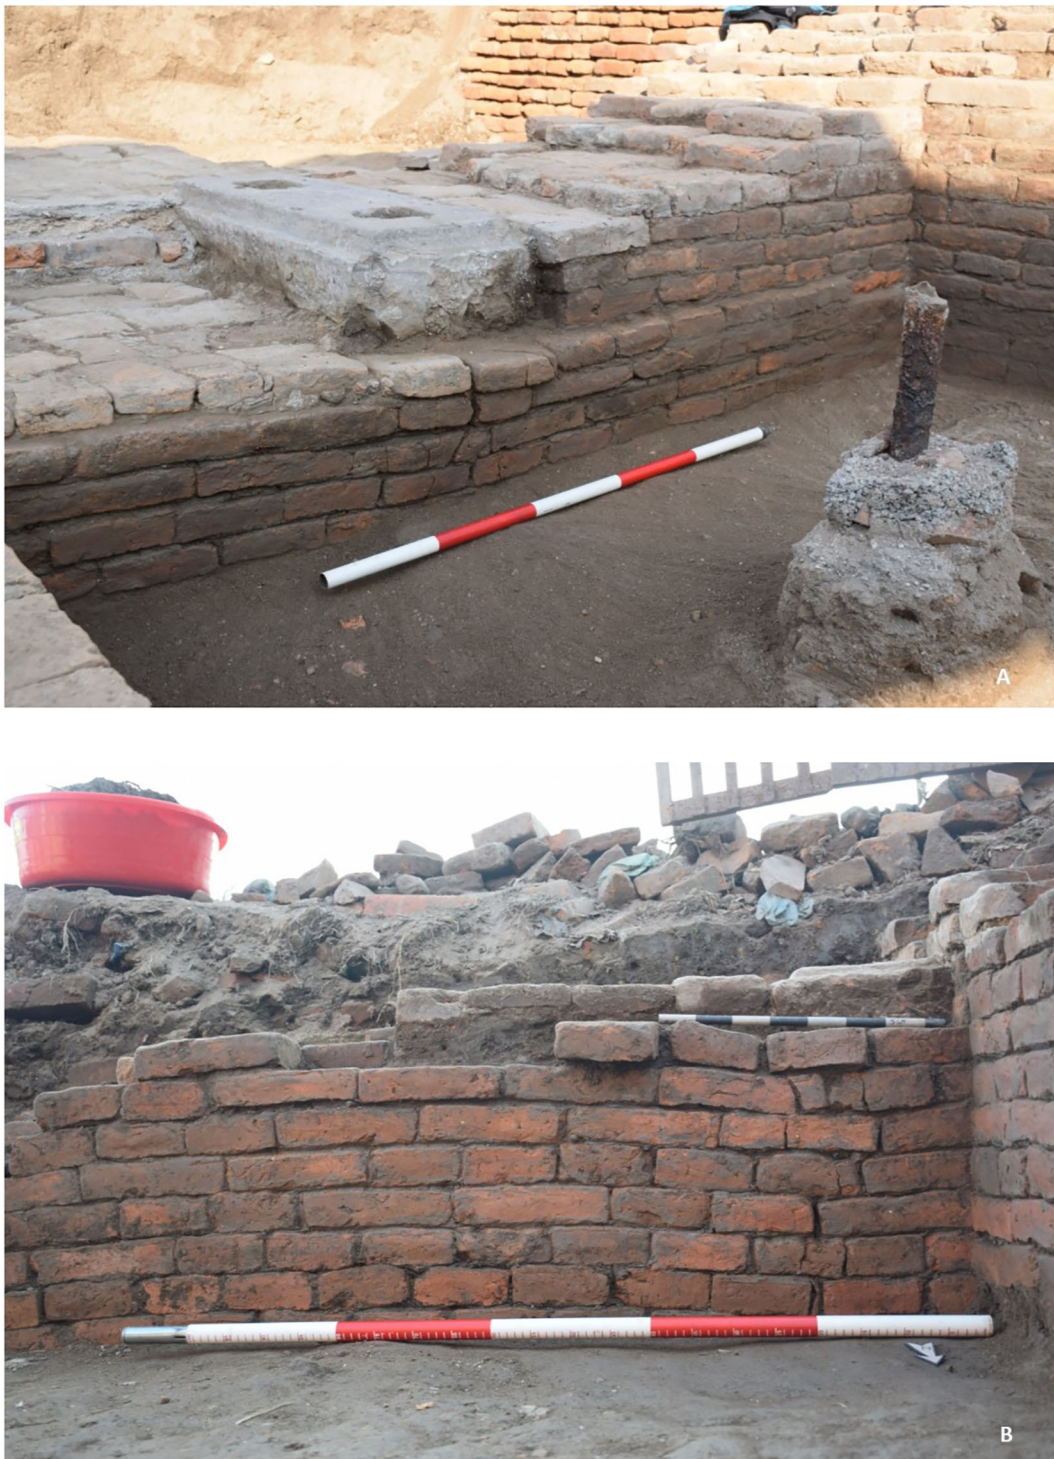
**Fig. 10** Vertical cracks identified below a double saddle stone in the foundations of the Kasthamandap (a) and below a saddle stone in the foundations of the Gurujyu Sattal, Pashupati (b)

It would appear that the use of mud mortars within the foundations allowed for flexibility of the monument during seismic events. The only damage that could be linked to earthquakes was the identification of short vertical cracks located below a double saddle stone on the western length of the main foundation of the structure. Limited to the upper courses, it indicates stress of the load of the saddle stone and its interlinked superstructure, primarily induced by the pressure of vertical movement during a seismic event, causing the foundation below to be damaged (Coningham et al. 2018: 171; Fig. 10a). This also indicates that potential areas of stress and damage were minimised and localised, rather than causing catastrophic failures. It is likely that such a design with mud mortar brick masonry foundations linked to saddle stones and the superstructure above was designed to save the structure from further seismic stress, limiting damage to a few specific locations. Similar damage patterns and deformation of brickwork were also identified during excavations at the Gurujyu Sattal

at Pashupati (Fig. 10b). Again, the load of the timbers placed within the saddle stones, which were bonded by mud mortar to the brick foundations, caused small concentrated areas of vertical cracks below.
