Ground Penetrating Radar Survey
of
an area to the South East of the Abbey Church of
Dunfermline Abbey
For
Dr Michael Penman
University of Stirling
19th September 2019

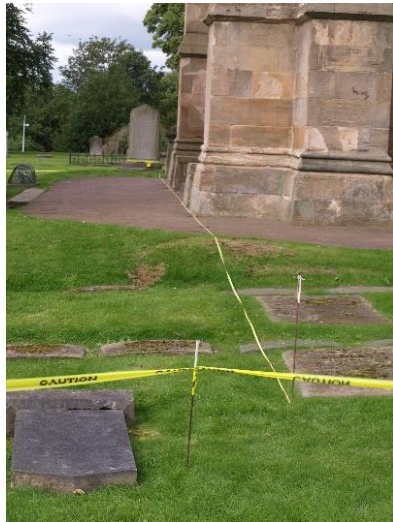
Figure 2: The position of survey line 1 relative to the south transept door.

Two parallel survey reference lines were laid out in along an East/West orientation. Line 1, to the North, was placed to align with the south front of the south transept (Figure 2). Line 0 was placed 8m to the south of Line 1 (Appendix A). This line lies along the path (Figure 3). Where a marker 1 has been placed on the 2-dimensional data, this indicates the position at which the radar crossed this survey reference line. Line 0 was used as the start point for the majority of the survey lines (see also Figure

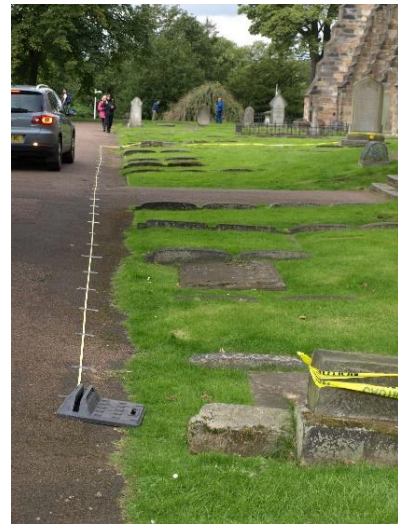
Figure 3: The position of survey line 0, parallel to and 8m South of line 1.

3). The West end of the survey aligns with the second buttress to the West of the South Transept door (Figure 4). The position of the survey lines were defined by GPS as shown in Appendix A. **ALEX – GPS Please**
